# Processing and Environmental Effects on Composite Repairs

The scarf-joint technique is one of the latest techniques used for repairing composite aircraft structures. But this technique is mostly used at depot level repairing activities since it requires autoclave and other equipments. This article focuses on scarf joint comprised of vacuum and autoclave precured and co-cured composite patches bonded to autoclave and vacuum precured parent laminates. Autoclave and vacuum cured parent laminates and scarf joints were prepared and exposed to the same temperature and moisture environment for comparison. All specimens were loaded in tension at three temperatures. Interlaminar shear strength (ILSS) tests were also carried out for the parent materials. As noted, the tensile strength and ILSS decrease when the material has been exposed to moisture and tested at elevated temperature. But, no significant difference was reported for either tensile strength or ILSS between autoclave and vacuum cured materials. The room temperature repair efficiencies are reported for single scarf repairs comprised of vacuum co-cured and precured patches. These vacuum cured repair efficiencies were found to b

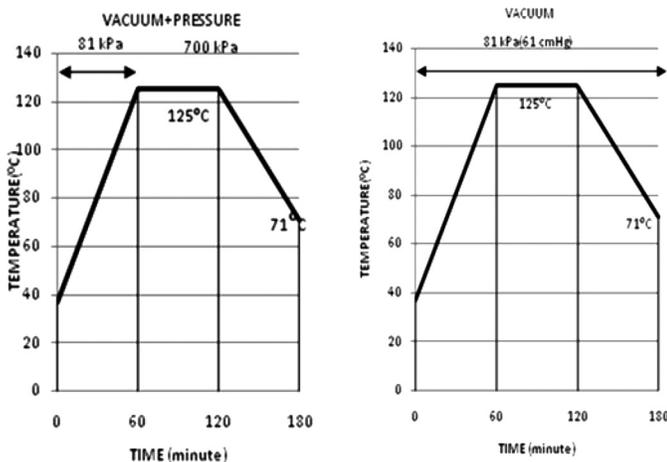
FIGURE 2.—Cure cycles for 913 G/7781 prepreg material.

The mechanical properties of laminates and adhesives are expected to be affected by the curing process. In this study, two curing processes for repair (autoclave and vacuum bag cure) have been used to process parent materials and patches. Patches were also processed by vacuum curing in-situ with cured parent laminates, which is generally called cocuring. The effects of each curing process and environmental exposure on the material properties have been investigated. The curing procedures developed for these two processes are given in Fig. 2.

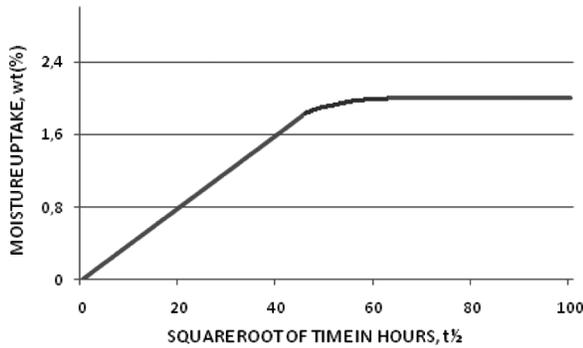
FIGURE 3.—Typical moisture uptake versus square root of time.

The specimens were weighed before, during, and after conditioning. They were removed from the vessel at pre-determined intervals and placed in a transient storage box until they cooled to the ambient temperature, and then they were weighed to the nearest 10<sup>-3</sup> gram. After the weighing, the specimens were returned immediately to the vessel. This weighing process was repeated until the equilibrium values of moisture uptake in the specimens were obtained. The weight gains were recorded as a function of time and the moisture uptake, determined as percent weight gain, was plotted versus the square root of time, see Fig. 3.

The average moisture uptakes in terms of weight gain percentages for ILSS specimens and tension specimens were 1.3% and 1.2%, respectively. For the repair tensile test specimens, the average moisture uptake was approximately 1.8%. It is shown that higher moisture content was obtained for the repaired parts. This was probably due to higher void content of the repaired area.

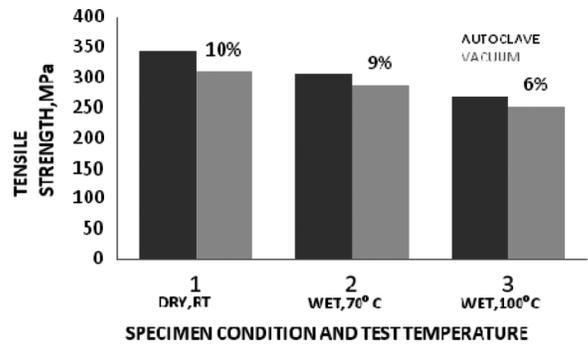
FIGURE 4.—Effect of curing process on tensile strength (RT = room temperature).

Considering the data obtained from the static tests of parent material performed at room temperature, 70°C, and 100°C on dry and conditioned specimens for both autoclave and vacuum cure cycles, it can be seen that the average ultimate tensile strength (343 MPa) of dry specimens at room temperature. for the autoclave cure

is 10% higher than the strength (309 MPa) of dry specimens at room temperature. for the vacuum cure. The wet specimens had differences in tensile strength between the autoclave and vacuum cures of 9% and 6% at 70°C and 100°C, respectively; see Fig. 4. These differences were considered insignificant and they indicated that vacuum cured patches could be an alternative to autoclave cured patches for repair in the field level maintenance facility.

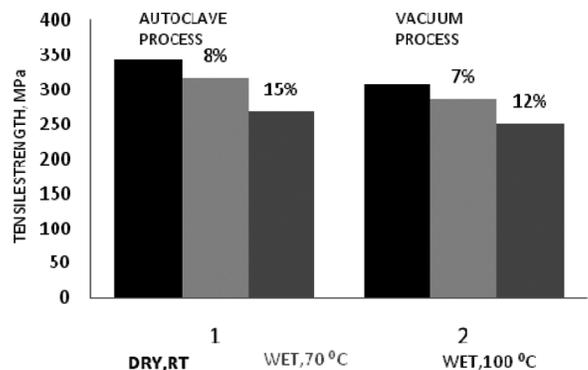
FIGURE 5.—Effect of moisture and temperature on tensile strength (RT = room temperature).

It was also noted that moisture (wet) conditioned specimens showed a decrease in tensile strength of up to 8% (from 343 MPa to 316 MPa) at a test temperature of 70°C and up to 23% (from 343 MPa to 268 MPa) at 100°C for autoclave cured material. Similar results were also obtained for vacuum cured specimens. The maximum decrease in strength was about 23%, which came from the effect of combining moisture, temperature, and curing process, see Fig. 5. Therefore, it is important in design to take the elevated temperature strength for this material into account, as the room temperature strength is significantly higher.

No significant change in strain at failure was observed in tension loading at different temperatures after moisture exposure, but a slight decrease of modulus was found to occur for both curing processes as the test temperature increased.
